**Flood Control Project Maintenance
Levee Inspections**
LMA District Cover Sheet
Spring 2018 Levee Inspection Results

Reclamation District No. 0544 Upper Roberts Island

Spring 2018 Levee Inspection Results

Waterway			Bank	Unit Miles
Unit No. 01 San Joaquin River			Left	6.05
	Spring (March - May)	Summer (June - August)	(September - November) Fall	Winter (December - February)
Unit Maintenance Rating (Fall Only)				
Date of Inspection	4/26/2018 - 4/26/2018			
DWR Inspector	Richard Willoughby			
Accompanied By	Richard Toy KSN

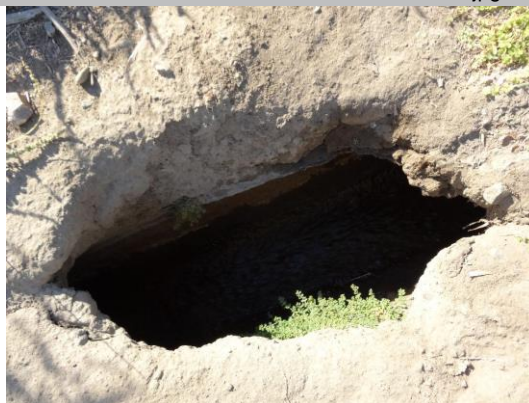
Photo 2 of 3 : UCIP_SP_2018_51375_43004.jpg

WS view: close view of levee slope with pits and holes.
